# Subterranean termite infestation in buildings

## protecting timber, buildings and furniture

### Termites 3

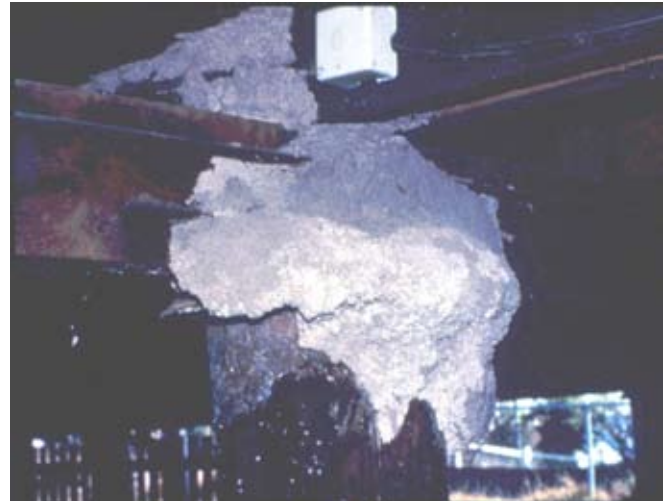
Figure 1. Physical barrier (termite shield) bridged by subterranean termites.

Methods employed in the erection of physical barriers during building construction are detailed in the Australian Standard AS 3660 series. These barriers impede and discourage termite entry into buildings. Termites can build around physical barriers (Figure 1), but are more readily detected during routine inspections.

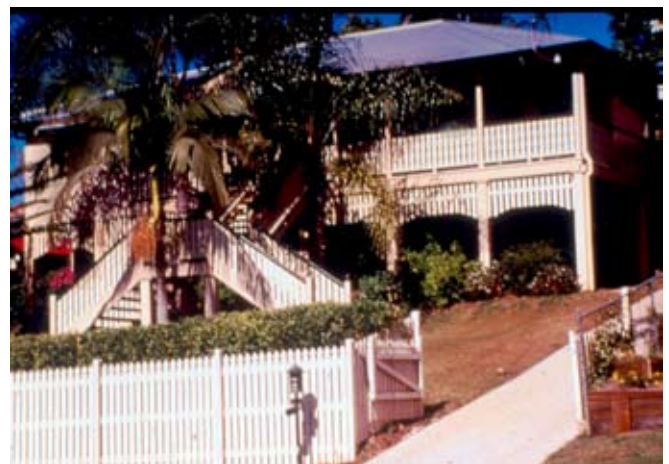
Figure 2. For suspended timber floors, termite shields and routine inspections provide adequate protection.

For suspended floors, termite shields (caps or strip shielding) have, for many years, been placed on foundation walls, piers, stumps, and other substructures to isolate the upper parts of the building from the substructure (Figure 2). Care should be exercised when enclosing the substructure area not to bridge termite shields superstructure. Stainless steel mesh can be used to provide these physical barriers (Figure 3).

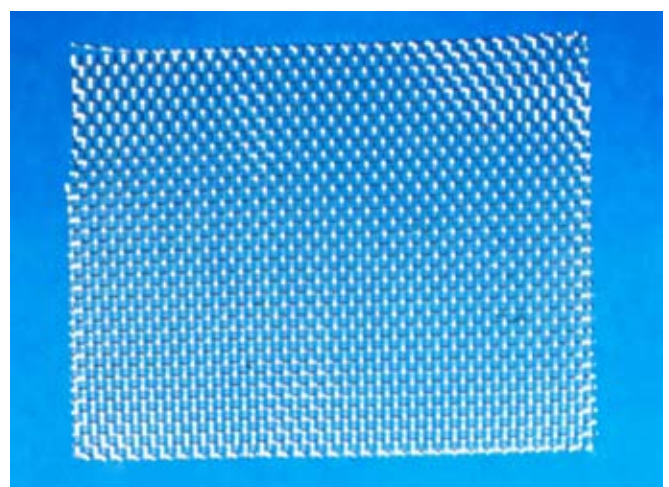
Figure 3. Stainless steel mesh can be used to provide physical barriers.

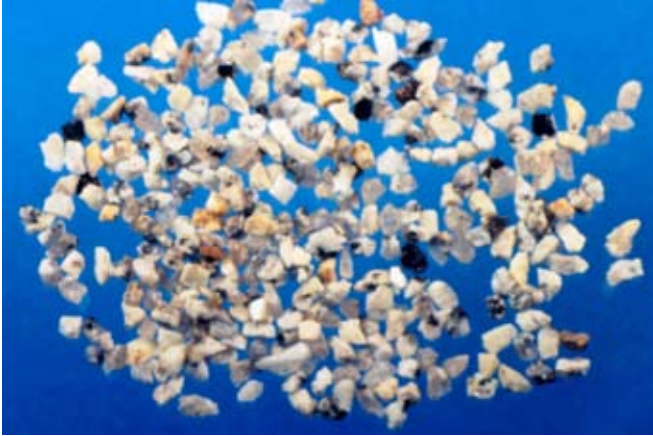
Figure 4. Graded stone barriers consist of compacted rock particles.

Stumps can be protected in-ground by graded stone barriers (Figure 4). The graded stone barriers consist of compacted rock particles of such a size (1.7–2.4 mm in diameter) that the termites cannot crawl between them, nor move them. Stone barriers are effective against *Coptotermes* spp. Further testing is required before a suitable particle size can be recommended for protection against other species of termite, especially the giant northern termite.

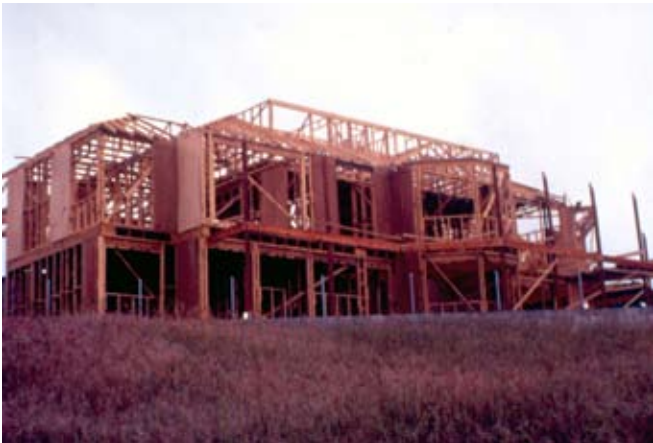
Figure 5. With slab-on-ground construction, many areas are inaccessible for inspection.

Modern building practices, such as those involving slab-on-ground construction (Figure 5), are not compatible with the incorporation of traditional physical barriers. The risk of termite entry into slab-on-ground constructions can be minimised by constructing slabs in accordance with Australian Standards AS 3600. The concrete should be placed, finished and cured using the procedures recommended by the Cement and Concrete Association of Australia to minimise cracks and voids. Control joints and slab penetrations can be protected by barriers such as stainless steel mesh or graded stone. These barriers can be also installed under the whole of the slab. Exposed slab edges provide ready detection of termite entry.

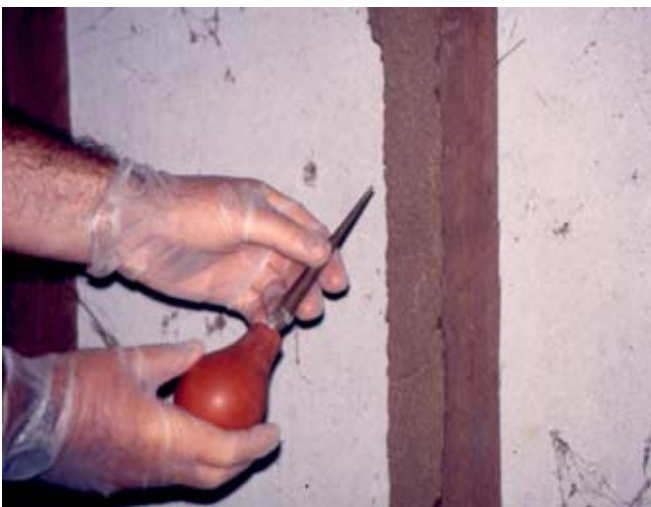
Figure 6. Toxic dust can be used to destroy the termite colony.

Toxic dust can be used to destroy a termite colony even when the nest has not been located (Figure 6). The treatment can be carried out only by an experienced operator licensed to obtain and use the dust.

The fine, dry dust (usually arsenic trioxide, fipronil, permethrin or triflumaron) is blown into occupied galleries by means of a hand blower. The dust adheres to the bodies of passing termites and is distributed into the colony. Arsenical dusting is ineffective against some species of termite, for example *Coptotermes frenchi*, which tend to avoid disturbed areas. Alternatively, termites may be aggregated using susceptible timber, removed, dusted and then returned to the site of activity to spread the dust through the colony. Boxes containing corrugated cardboard and susceptible timber, placed in the soil near termite activity, can facilitate aggregation. For these methods to be effective and safe, operator skill is required to judge the quantity of the dust needed and its placement.
